## ADVANCED FLIGHT CONTROL ACTUATION SYSTEM (AFCAS - E/P)

Fabrication and Design Verification Testing of a  
Dual Mode Electro/Pneumatic Actuator for the  
T-2C Aircraft

Bendix Corporation  
Flight Systems Division  
Teterboro, New Jersey

APRIL 1982

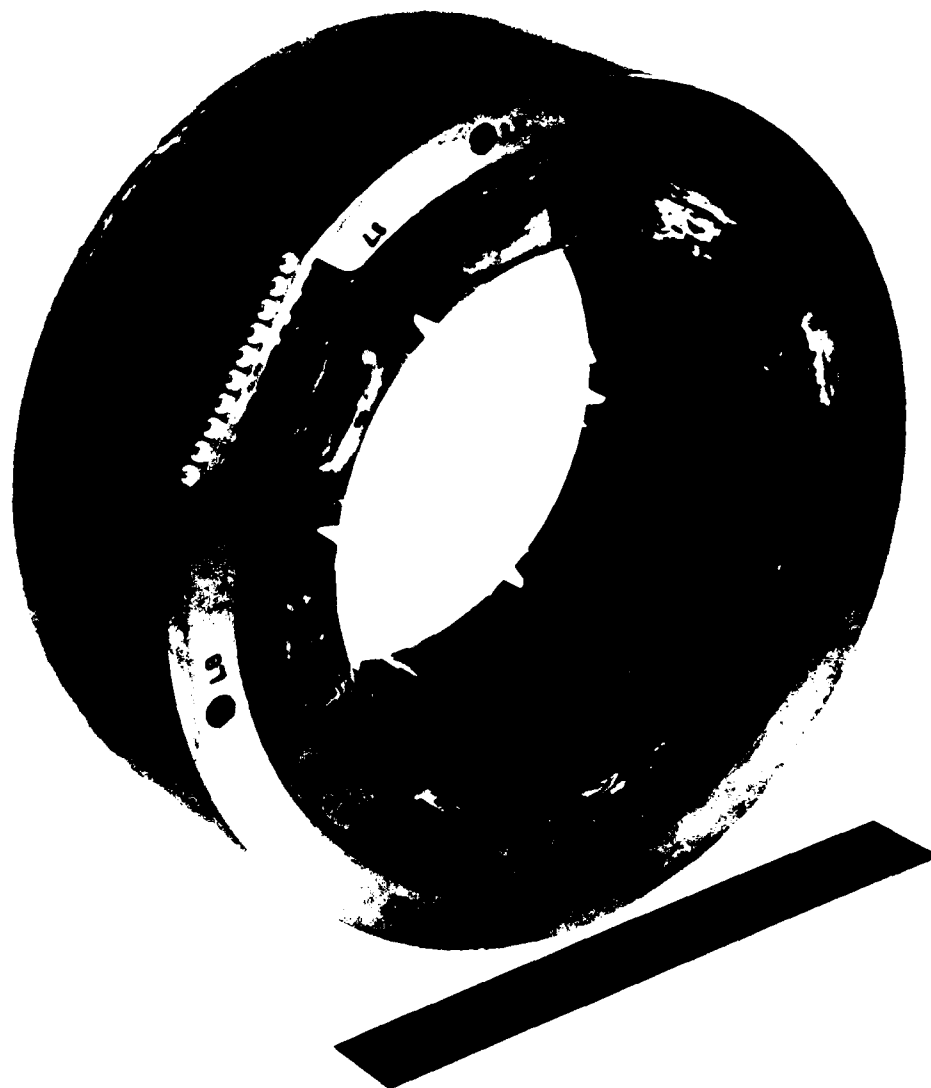
FIGURE 4

STATOR ASSEMBLY

Final assembly of the actuator commenced with the stator assembly shown in Figure 4. . This vendor fabricated unit consisting of stator laminations, pole coils, and vane blocks is the main structure of the actuator. The left manifold plate assembly, shown in Figure 5 prior to cementing the pneumatic transfer and manifold plates together, was assembled to the stator. A neoprene rubber gasket provides the proper sealing between the stator and manifold plate. The fixed output end gear, precisely positioned by a dowel pin and pilot hole arrangement was assembled to the manifold plate. The ring gear and roller bearings (Figure 6) were next assembled to the rotor (Figure 7). The rotor assembly, vanes, and output shaft were then slipped into place. Figure 8 is a photo illustrating the major internal components of the actuator. All gearing was coated with a molybdenum disulphide base lubricant, Bendix E.P. Lube Compound No. 1700-15.

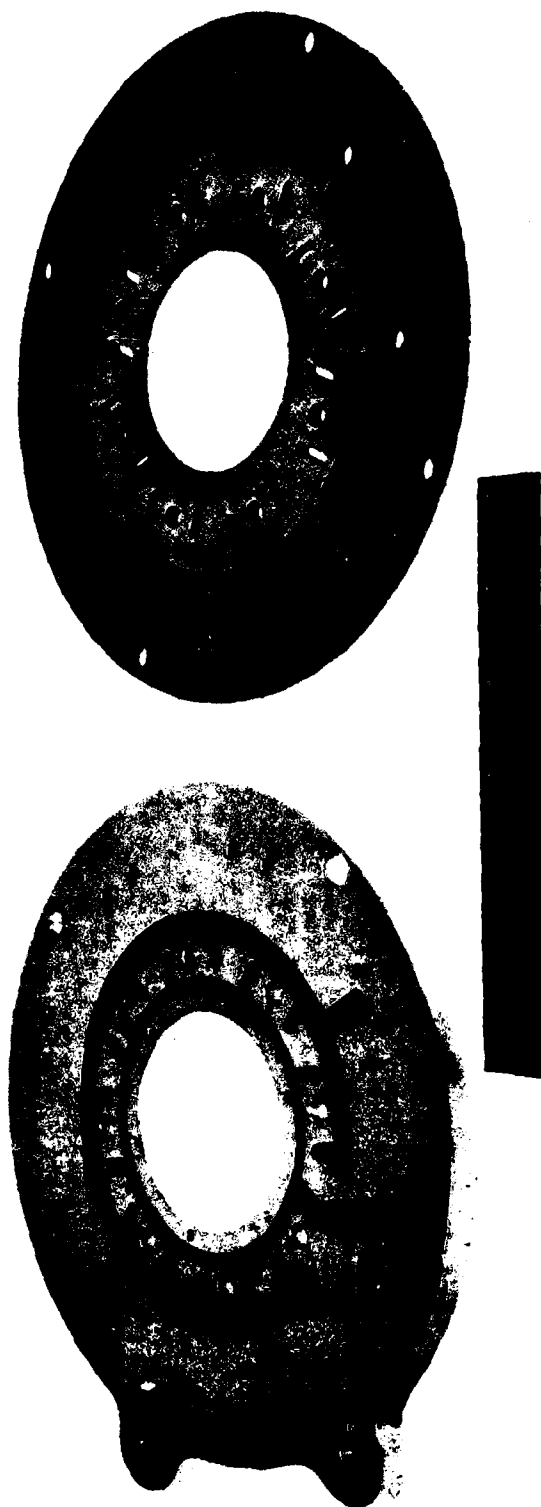
FIGURE 5

LEFT MANIFOLD PLATE - LEFT  
PNEUMATIC TRANSFER PLATE

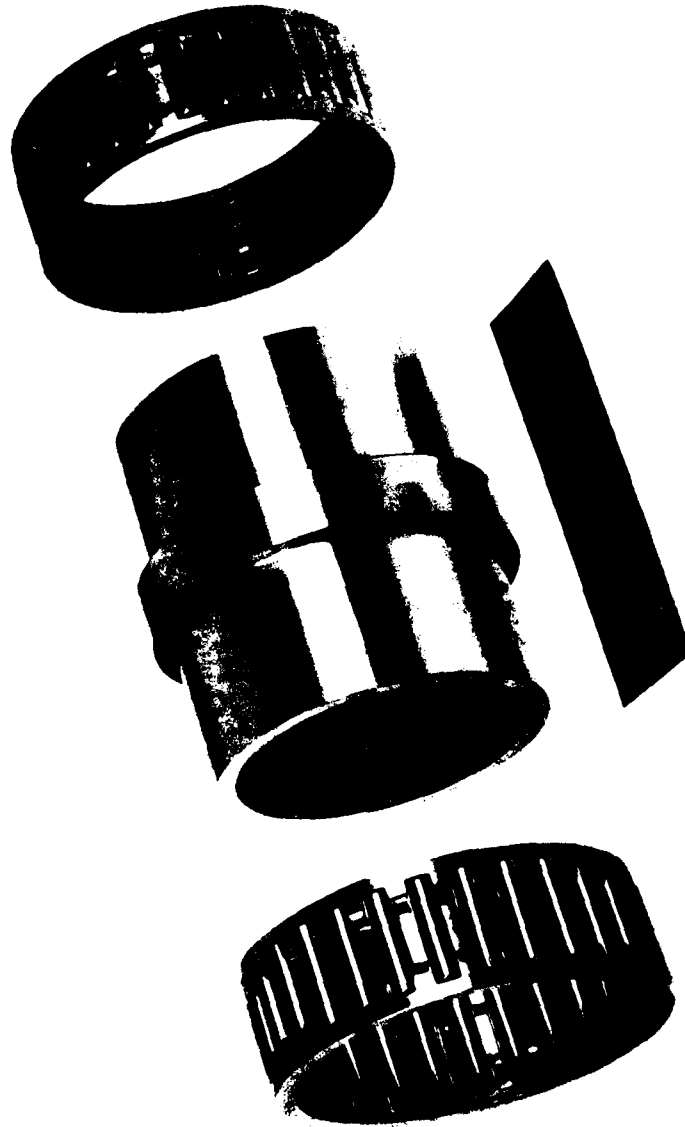
FIGURE 6

ROLLER BEARINGS - RING GEAR

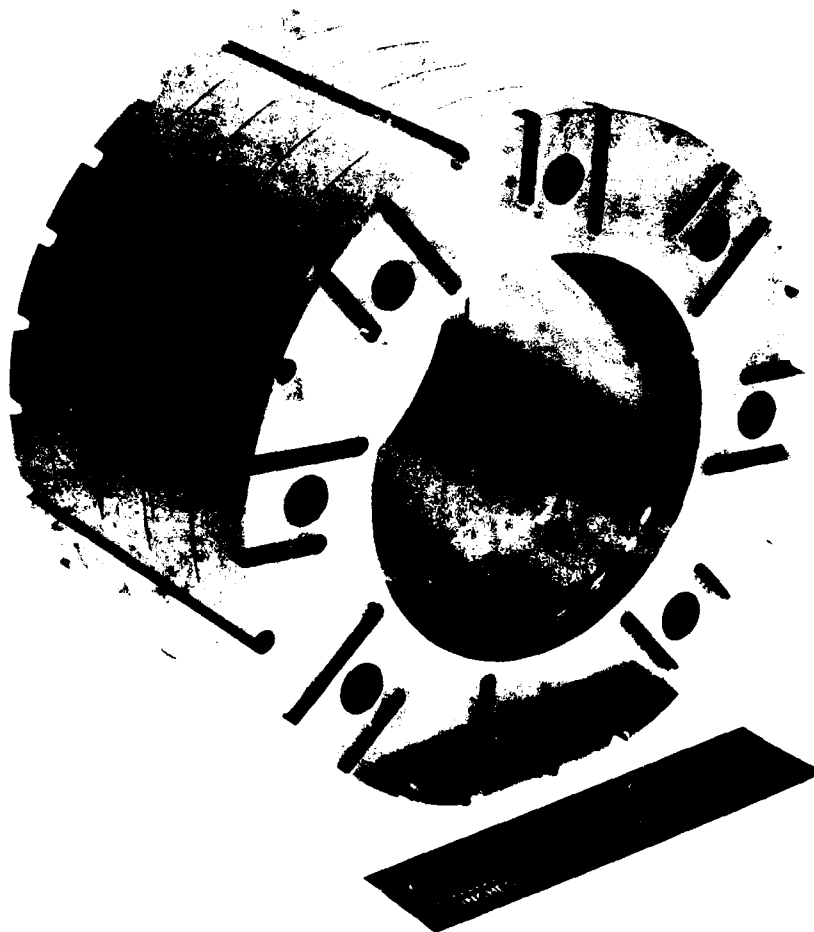
FIGURE 7

ROTOR

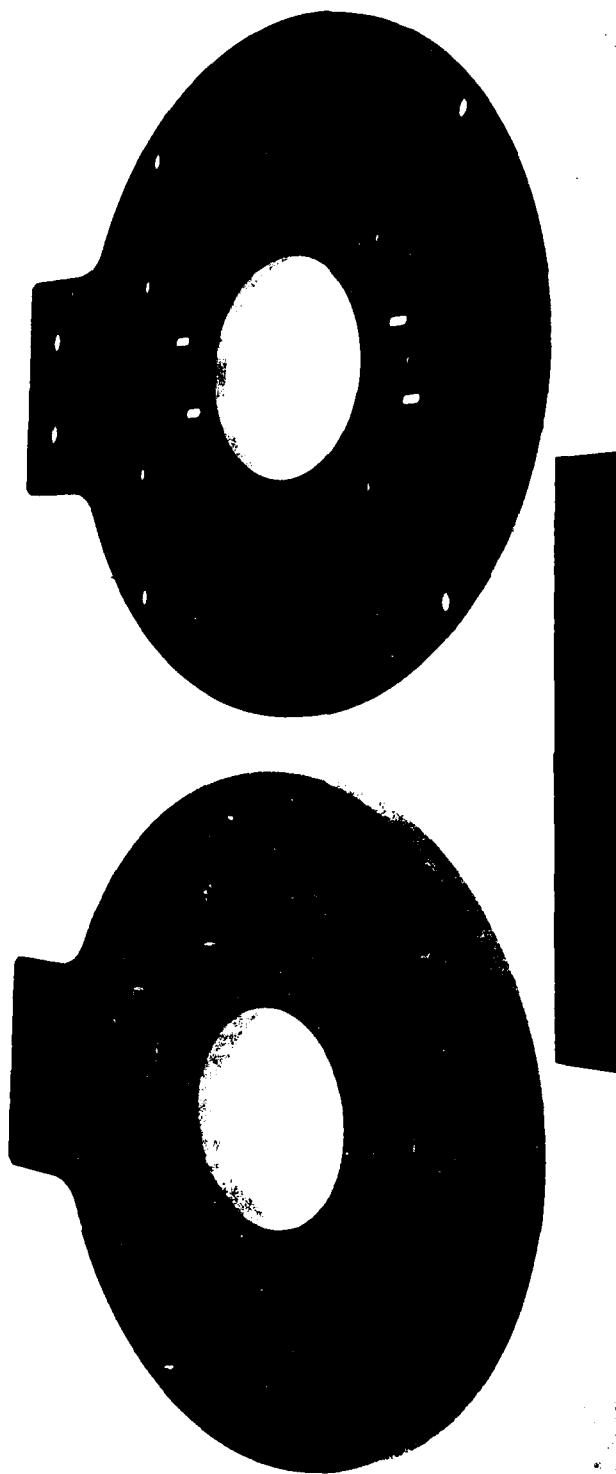
FIGURE 9

RIGHT MANIFOLD PLATE - RIGHT  
PNEUMATIC TRANSFER PLATE

The right manifold plate (Figure 9) was then installed followed by insertion of orbit shafts at eight places. Retaining rings hold the orbit shafts in position. Assembly of the fixed output end gear to the right manifold plate essentially completes the rotary motor portion of the actuator. Shimming between the end gears and manifold plates provides an adjustment for setting the output shaft end shake.
